## TPA-TCT beam position monitoring

F9 weekly meeting, 15. 04. 2022

Bojan Hiti, F9, Jožef Stefan Institute (JSI)

# Background TPA-TCT setup

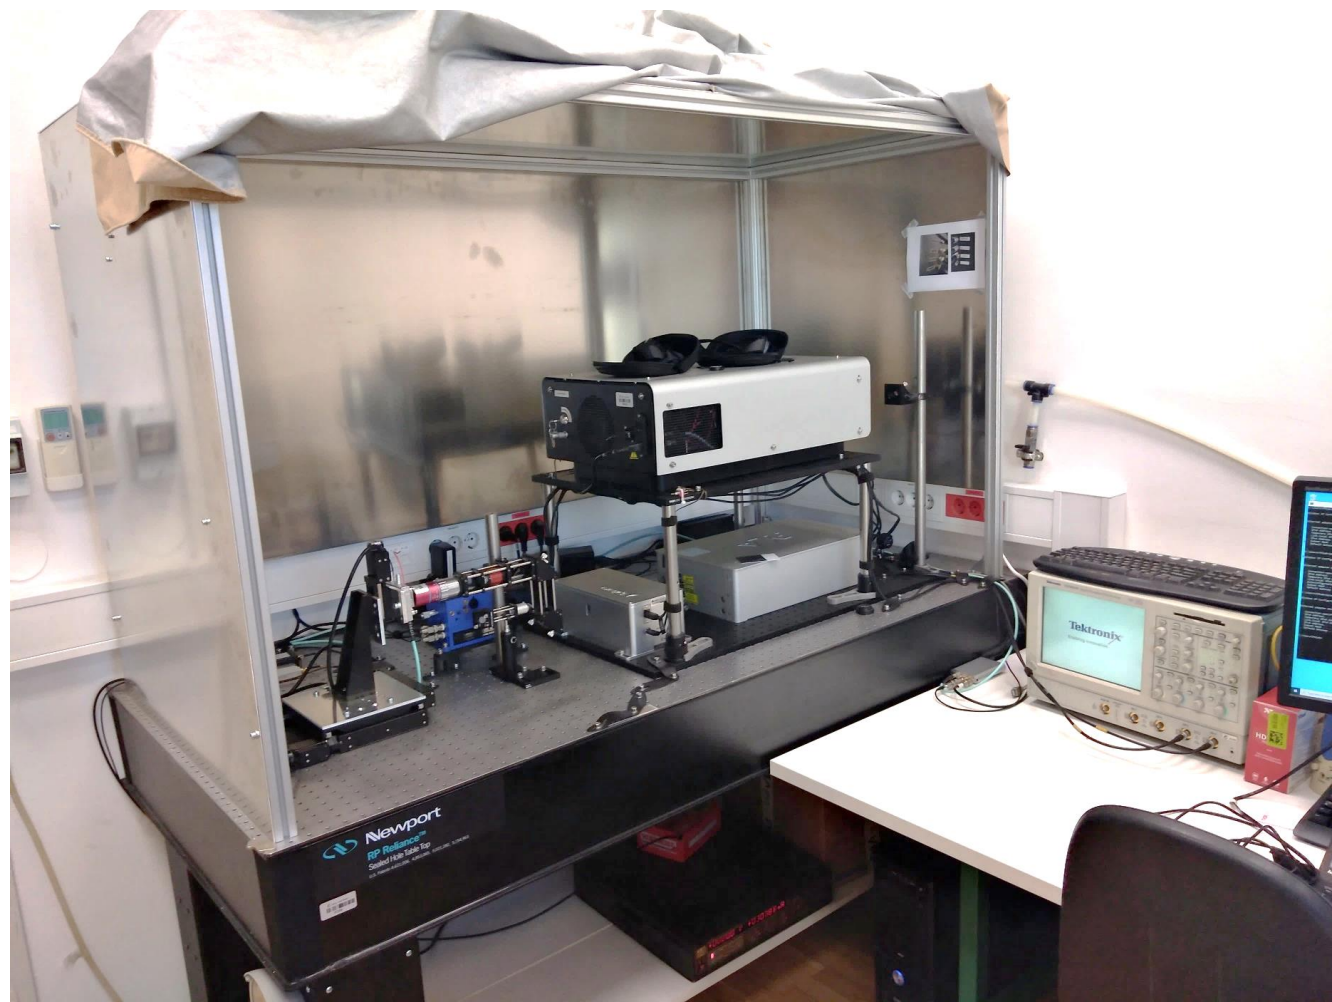
- 1550 nm infrared laser
- Pulse duration  $\approx 500$  ps
- Repetition rate 8 MHz down to Hz
- Max power at 8 MHz  $\approx 150$  mW before objective
- Beam waist size 1–2  $\mu\text{m}$  (Rayleigh length 25  $\mu\text{m}$ )
- **Imaging**
  - Online monitoring of beam position on display
  - Fluorescent IR CCD camera
  - Bright field microscopy with coaxial illumination
  - 5 W tungsten light bulb (W5W car lamp)
- ARRS project submitted this year

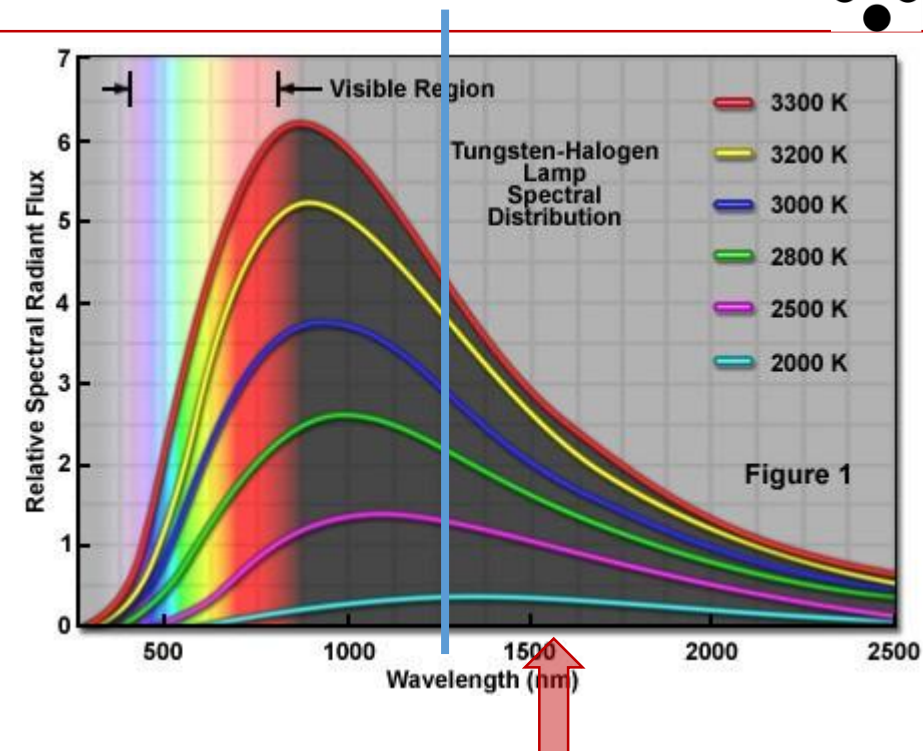
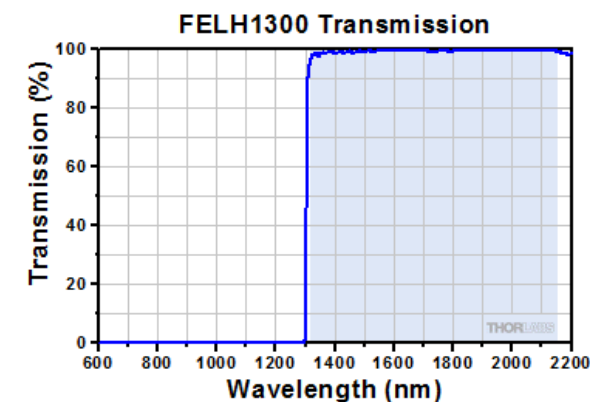
- Illumination  $\geq 20$  % max power causes electrical breakdown in test sample
  - Long pass filter (cut-on 1300 nm ?) to remove non-used part of the spectrum ?
- Surface not visible from the back side
  - Silicon should be transparent to 1500 nm
  - Not sure how to fix
- Known large pulse-to-pulse deposited energy variations (20 %)
  - Considering using frequency doubler crystal + Si photodiode (a la Cantabria, [I. Vila 39th RD50 workshop](#)) for monitoring & compensation
- Retry single event burnout tests with irradiated LGAD
