# PQC setup status

### Probe card

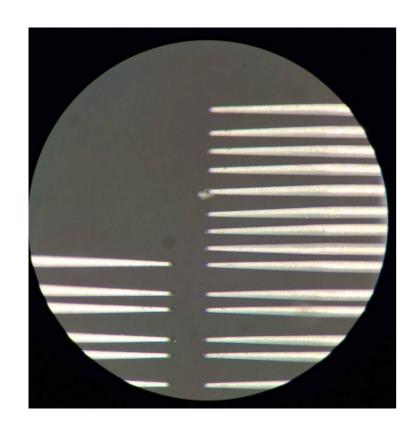
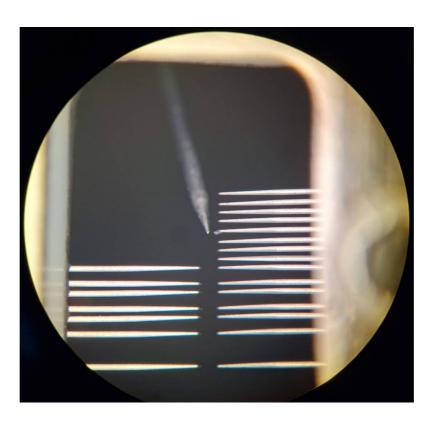
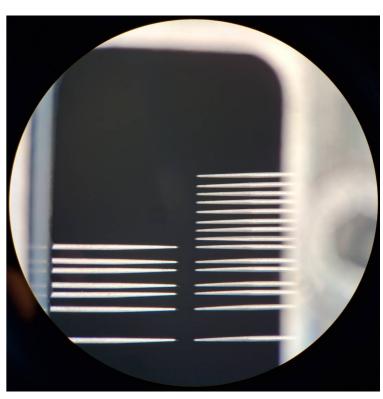
Speck on one of the needles successfully removed using a probe needle

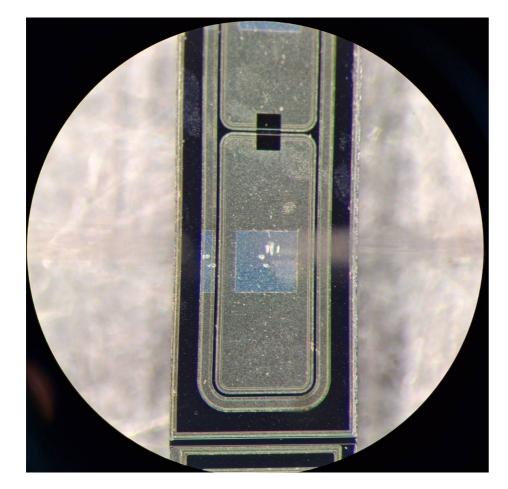
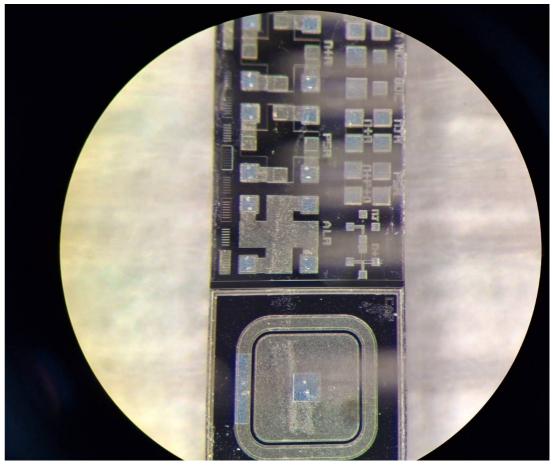
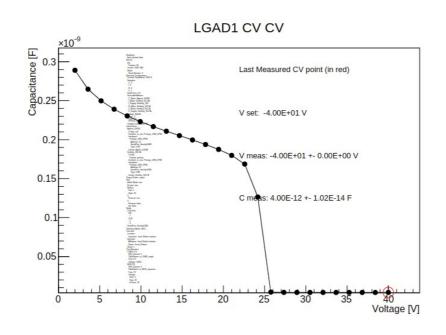
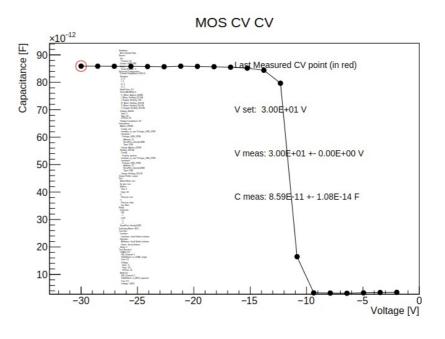
#### Probe card

Probe card alignment checked and looks good – all needles touch down at the same time

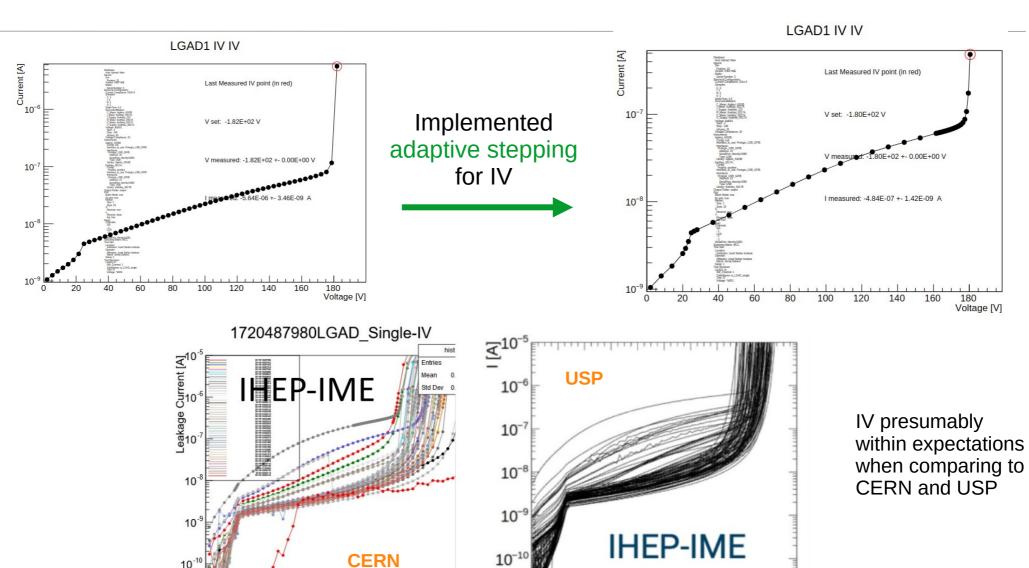
#### IHEP non-irradiated

40 60 80 100 120 140 160 180 20 Bias Voltage [V] 20 40 60 80 100120140160180200 V [V]
