# USTC\_W3-19\_0e14\_main sensor test

- Recycled main sensor from LTS study
- Mounted on Santa Cruz board
  - Col 3 Row 2 to signal
  - All other pixels + guard ring to GND
- - 30 C
- Analysis done this morning, needs a little refining

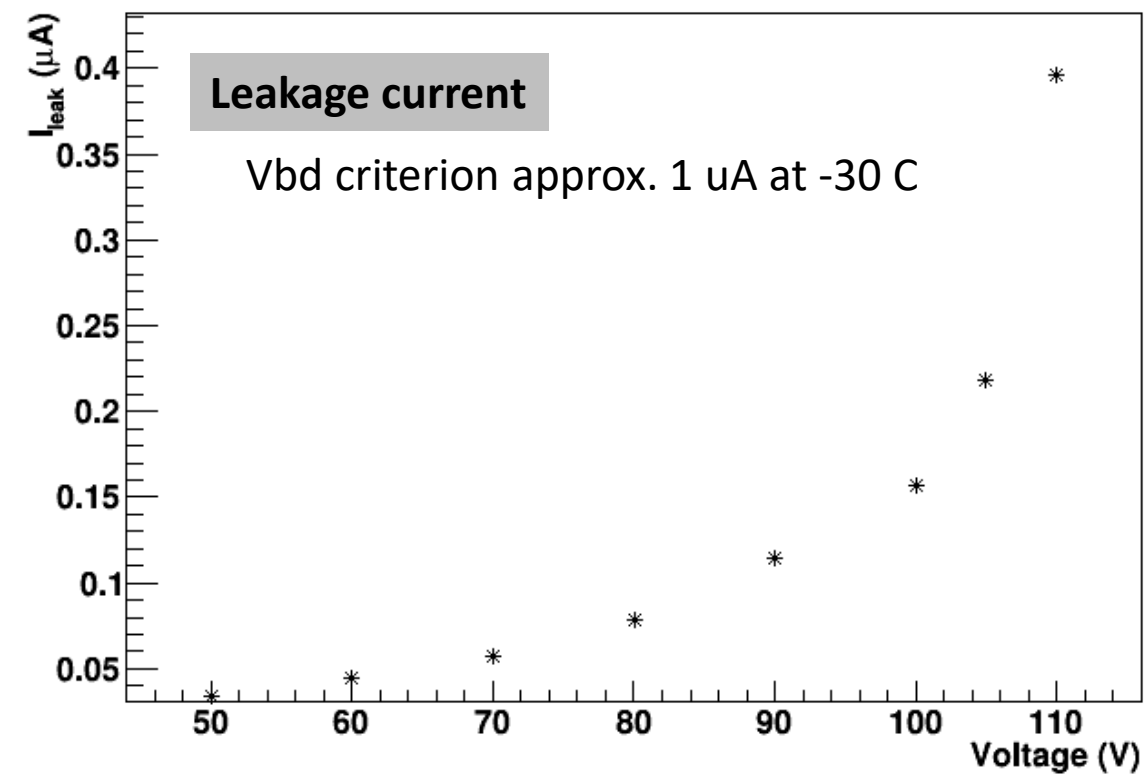
Leakage current T = 0 C
