# Module holder with module installed

# Module assembly info

## PP029

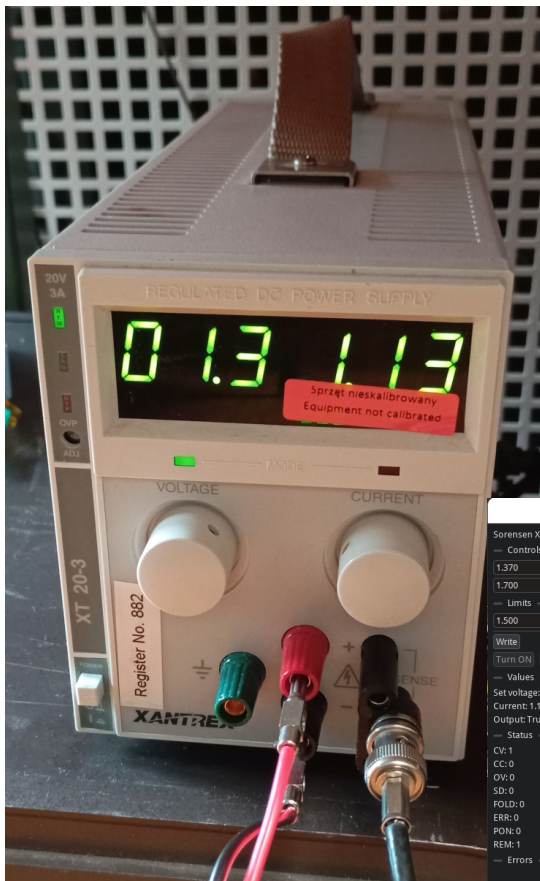
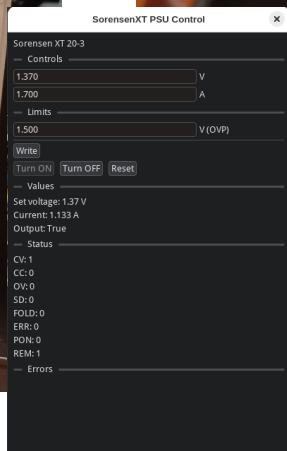
Replaced old power supply (Keithley 228A) with new 20 V 3 A linear supply (Sorensen XT 20-3)

Control with GPIB (fixed one prologix interface board, trace was disconnected)

Soft turn ON/OFF, over voltage protection, use sense wires to compensate drop on supply cable (1.2 A at 1.34 V)

Some issues with power supply connector (resistance varies with amount of strain on cable)
